**Inspection Report**  
**Minerals Regulatory Program**  
**March 29, 2011**

<b>Mine Name:</b> Eureka Rock	<b>Permit Number:</b> S/023/0094
<b>Operator Name:</b> Eureka Rock LLC	<b>Inspection Date:</b> March 24, 2011
<b>Inspector(s):</b> Wayne Western	<b>Time:</b> 10:00 -10:15 AM
<b>Other Participants:</b> None	<b>Mine Status:</b> ACT

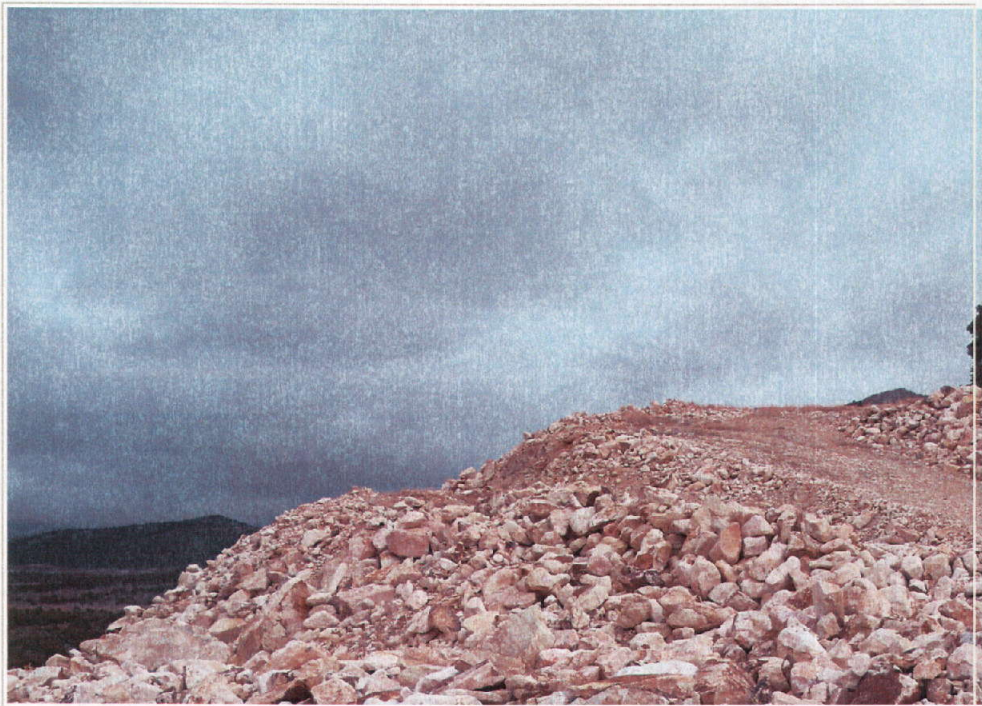
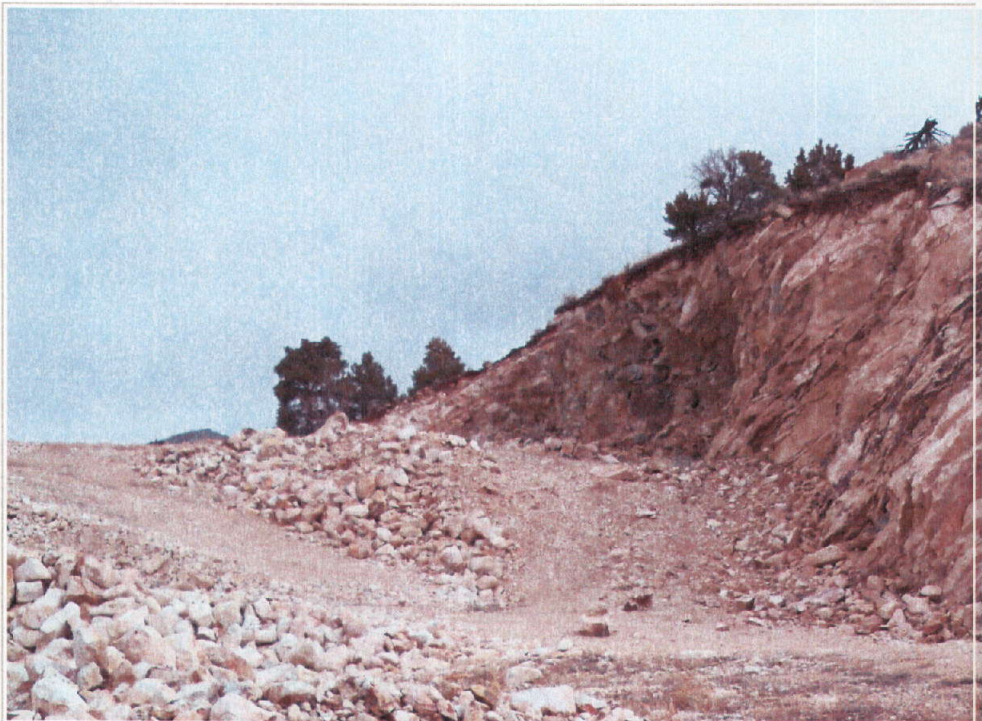
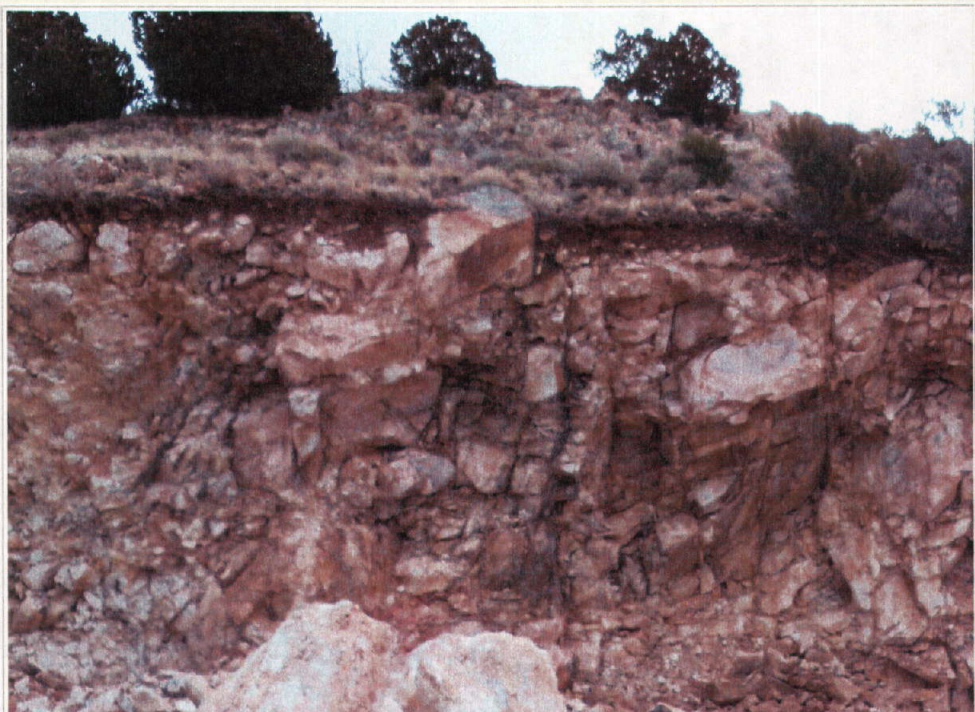
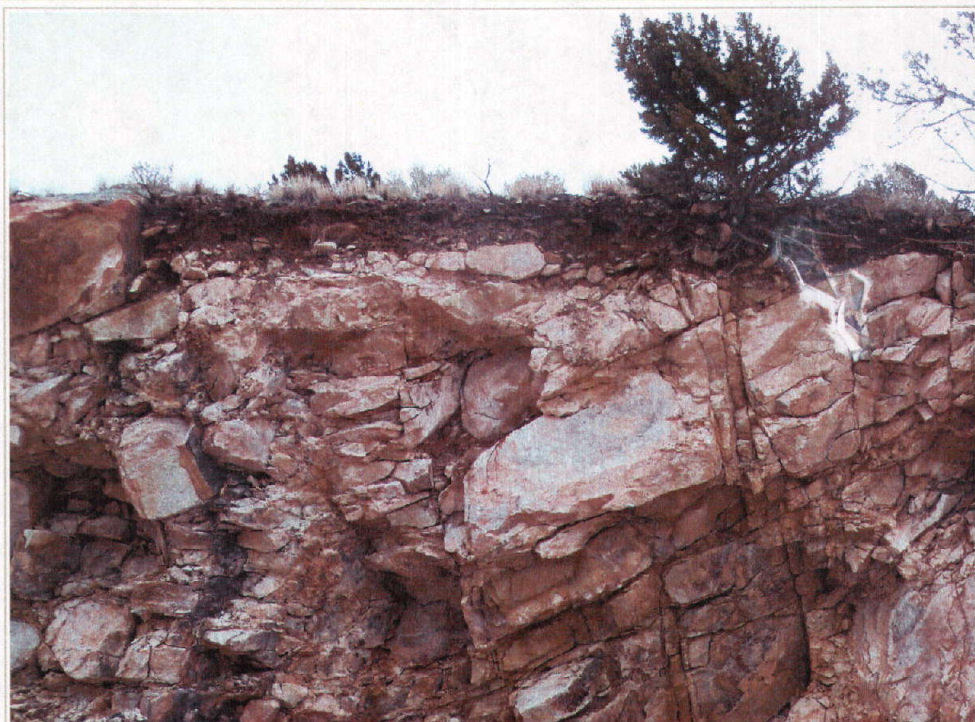
The site was not being worked at the time of the inspection. Photographs were taken to document the site.

There are rock overhangs on the highwall that must be removed.

The Division should sent a Division directive to the Operator requiring that the bond be increased and remove the overhangs.
